**Docket No. 217 – Development and Management Plan Inspection**

Northeast Utilities Service Company Certificate of Environmental Compatibility and Public Need for the construction of a 345-kV electric transmission line and reconstruction of an existing 115-kV electric transmission line between Connecticut Light and Power Company's Plumtree Substation in Bethel, through the towns of Redding, Weston, and Wilton, and to the Norwalk Substation in Norwalk, Connecticut.

**Date:** June 1, 2005

**Location:** Norwalk Substation Expansion

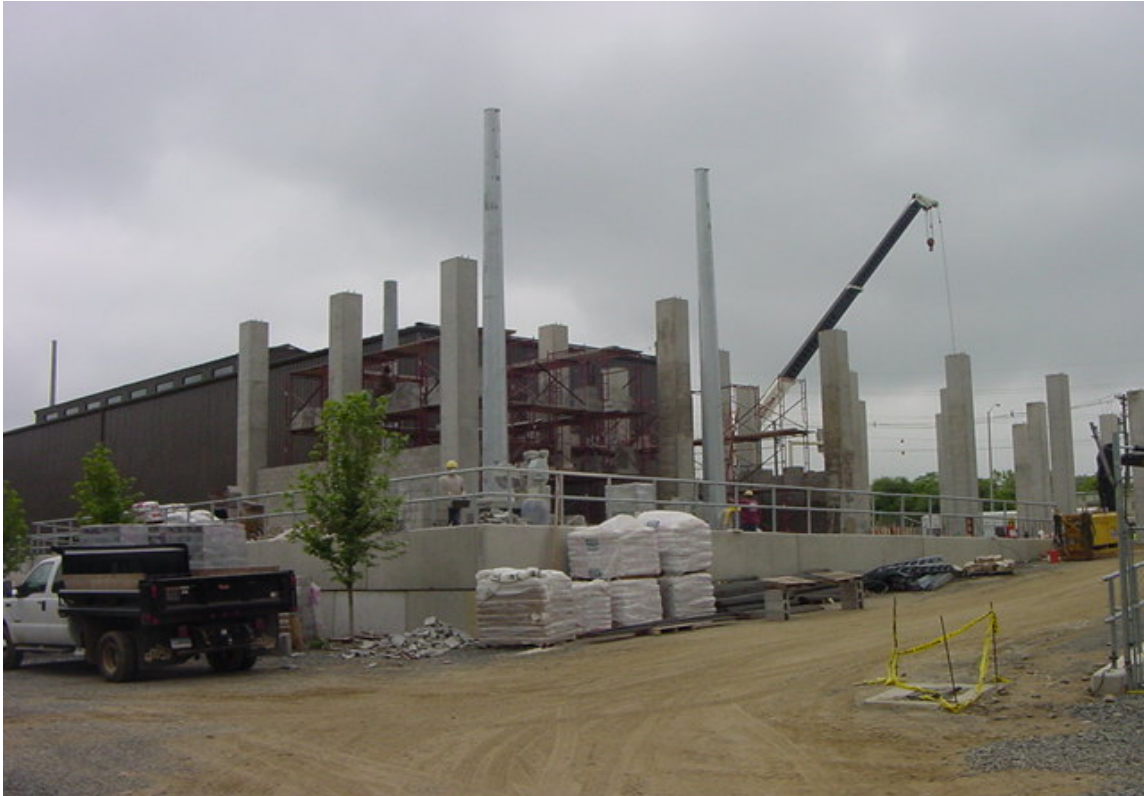
Foundation construction	<ul style="list-style-type: none"> <li>- Soil from the stockpile was being used in front of the GIS building for backfill. 6/01/05</li> <li>-Work on the structures and excavation near retaining wall #3 and the control house is ongoing, including rebar installation. 6/01/05</li> </ul>	<ul style="list-style-type: none"> <li>- None at this time. 6/01/05</li> <li>- The excavation and work is well within the yard and areas are contained, no issues at this time. 6/01/05</li> </ul>

Norwalk Substation- Structure work continues in front of the GIS building. 6/1/05

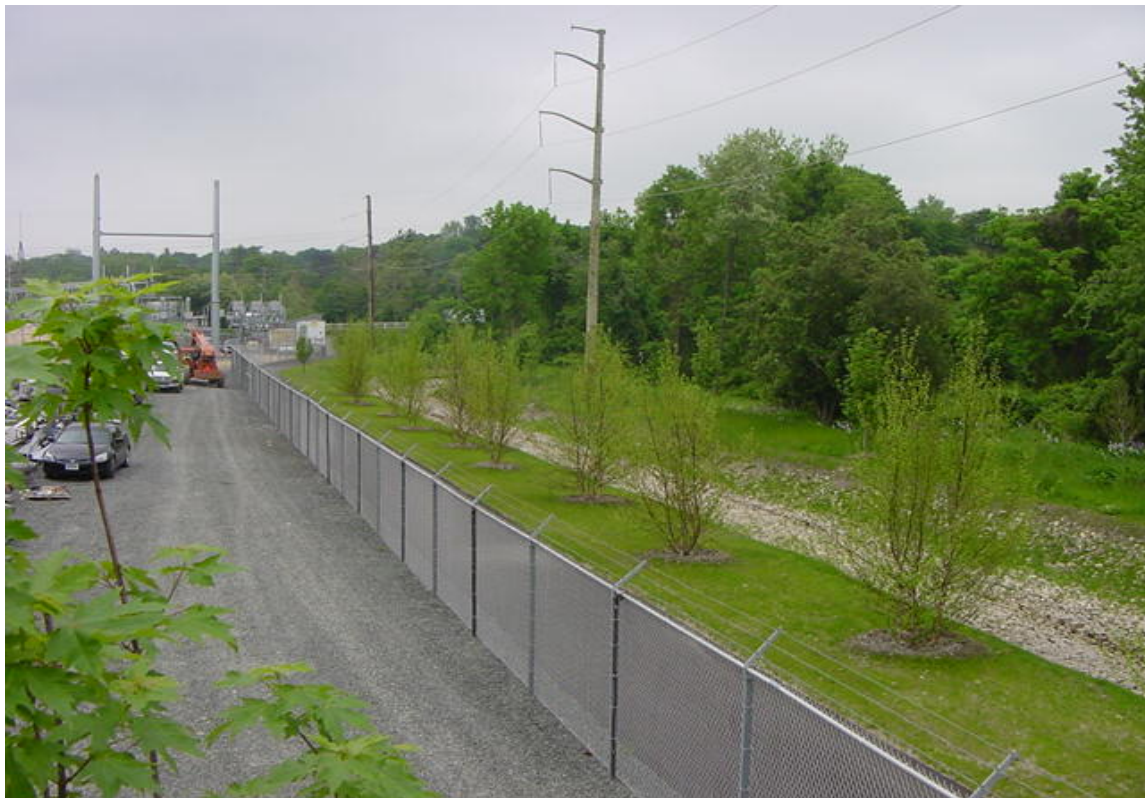
Areas of Inspection	Observation	Recommended Action
Erosion and Sediment Controls (includes inspection within 24 hours of a storm event)	-The overflow channel continues to work well with some minor erosion along the slope and grass growth is noticeable along the sides. The plantings within the channel are also showing good growth 4/27-6/01/05.	- Continue to monitor for overall stabilization. Vegetative growth appears to be off to a good start and the situation should be evaluated later in the growing season. The minor erosion may require repair if it worsens. 6/01/05

Overall view of the overflow channel along the Norwalk River. 6/1/05

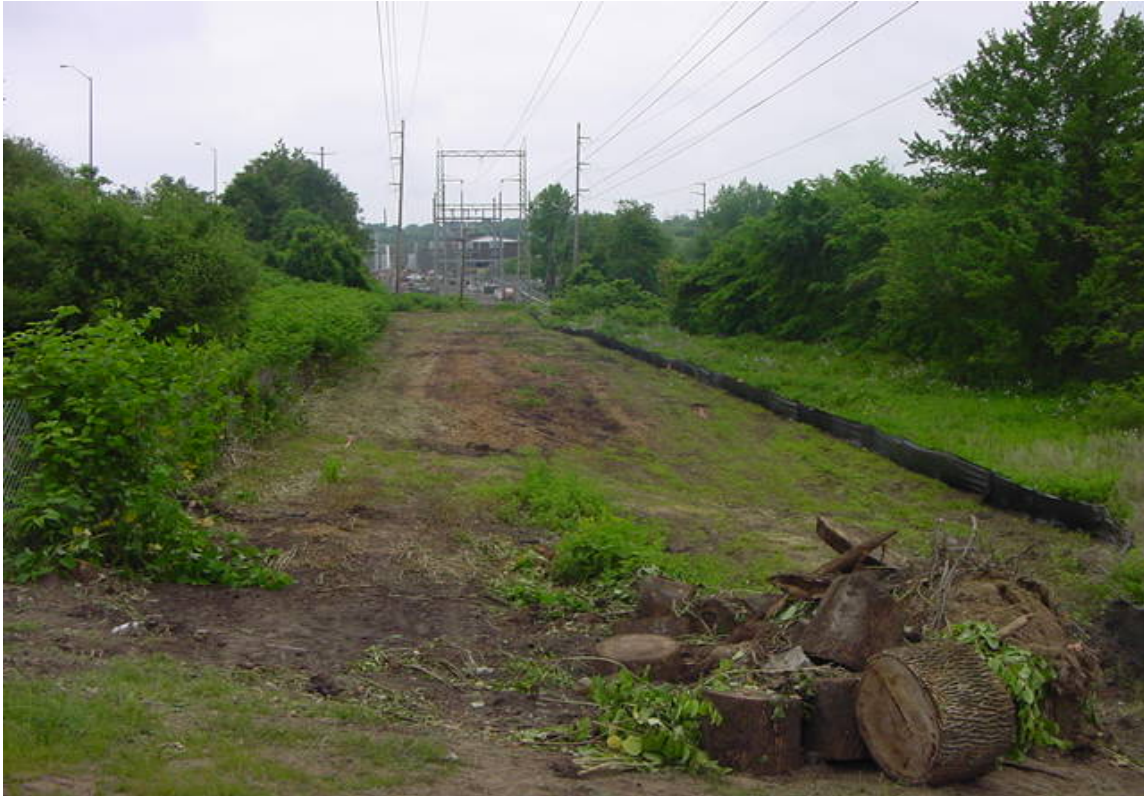
The work pictured is actually part of the 115 kV approach to the substation. The right of way from Broad Street was cleared and silt fence is in place. 6/1/05

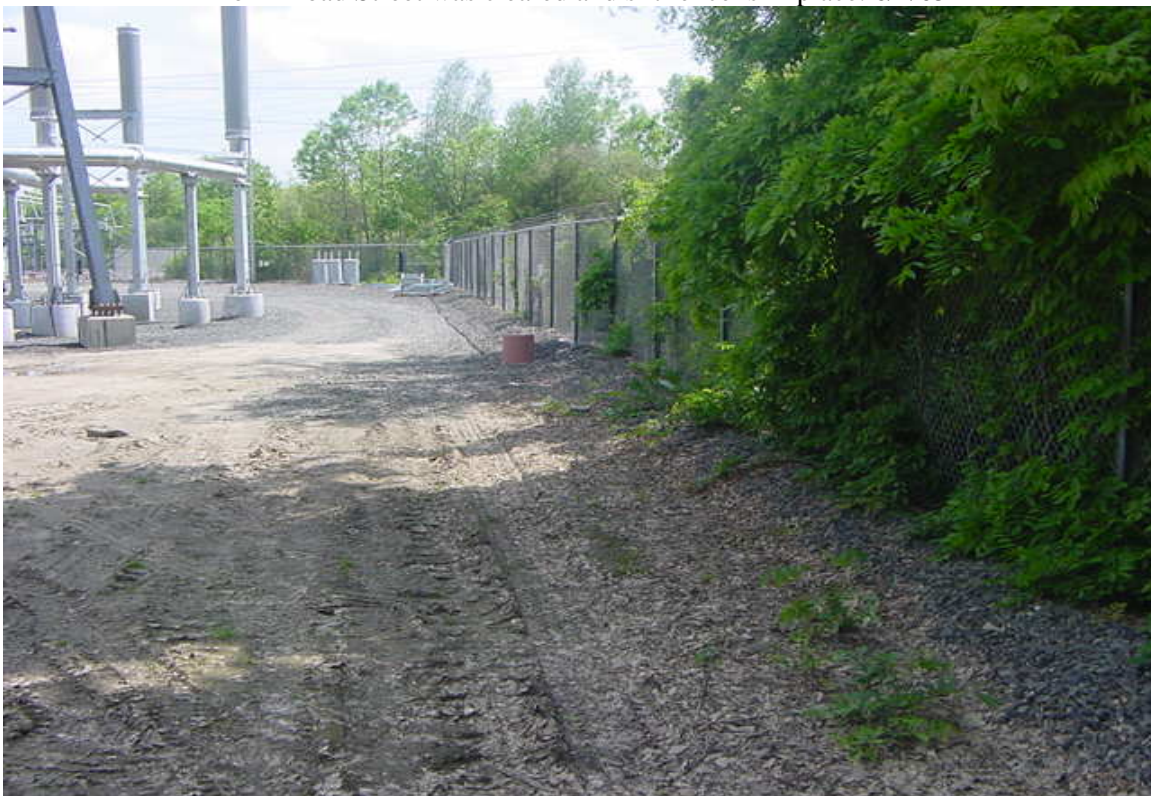
- There is no silt fence in place at this time, however the stone perimeter berm is in place and contains the yard well. 6/01/05	-All stockpiles are well-contained and the berm is working effectively at this time. 6/01/05

Plumtree Substation- The stone berm located around the site perimeter is still well in place. 6/1/05

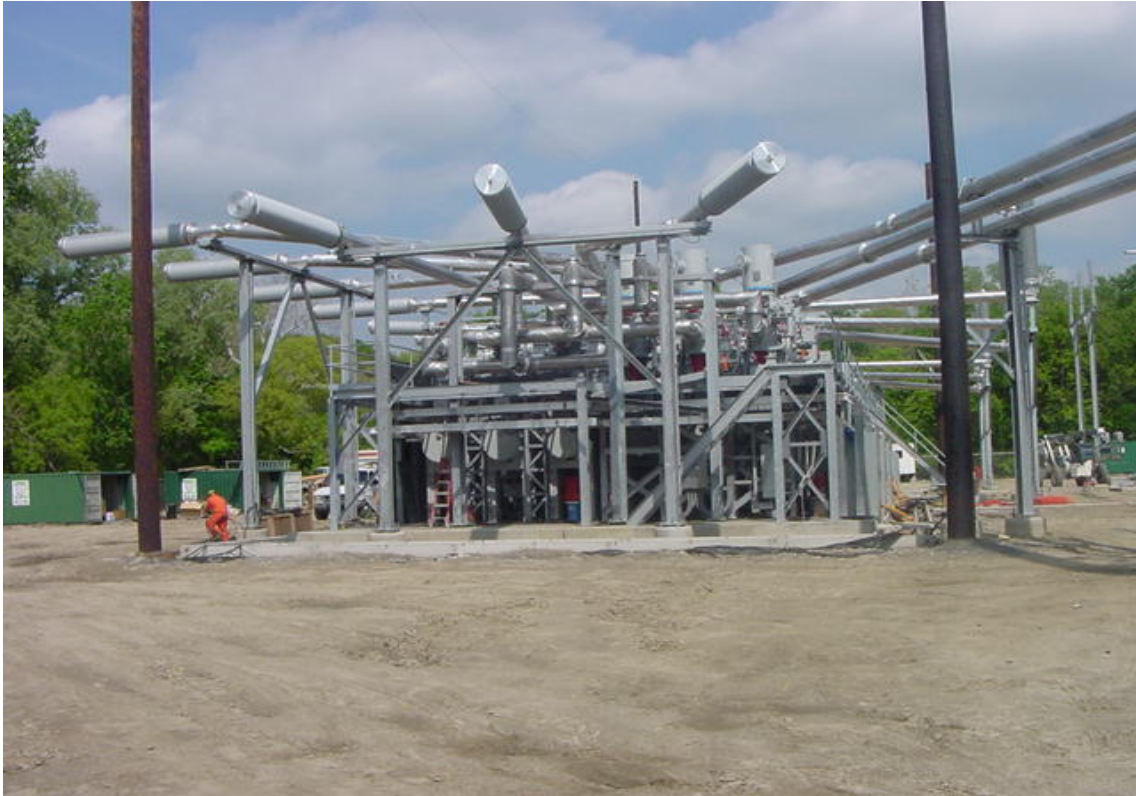
A majority of the work on the equipment on the pad is completed. 6/1/05
